RIPARIAN CORRIDOR MONITORING REPORT
CARMEL RIVER
2009

Thomas Christensen & Elizabeth Geisler
Monterey Peninsula Water Management District
5 Harris Court, Building G
Monterey, CA 93940

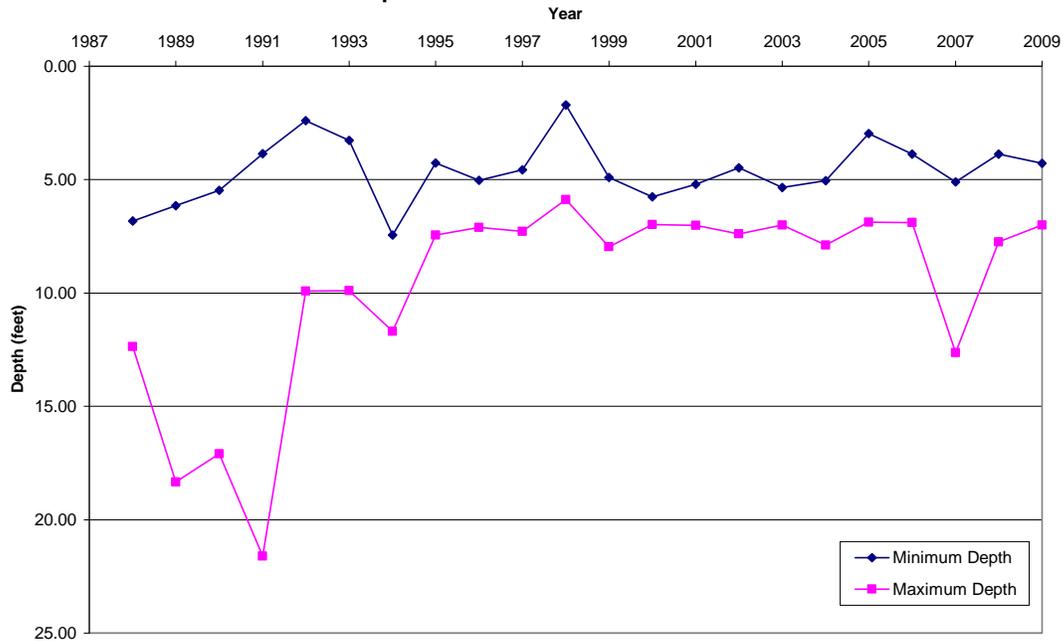
DeDampierre Monitoring Well (T17S/R2E-03La) Annual Minimum and Maximum Depth to Groundwater Values in Feet
